Technical Report CHL-97-5
March 1997

Monitoring Completed Navigation Projects Program

Burns Harbor, Indiana, Monitoring Study

Volume I: Overview of Approach and Results

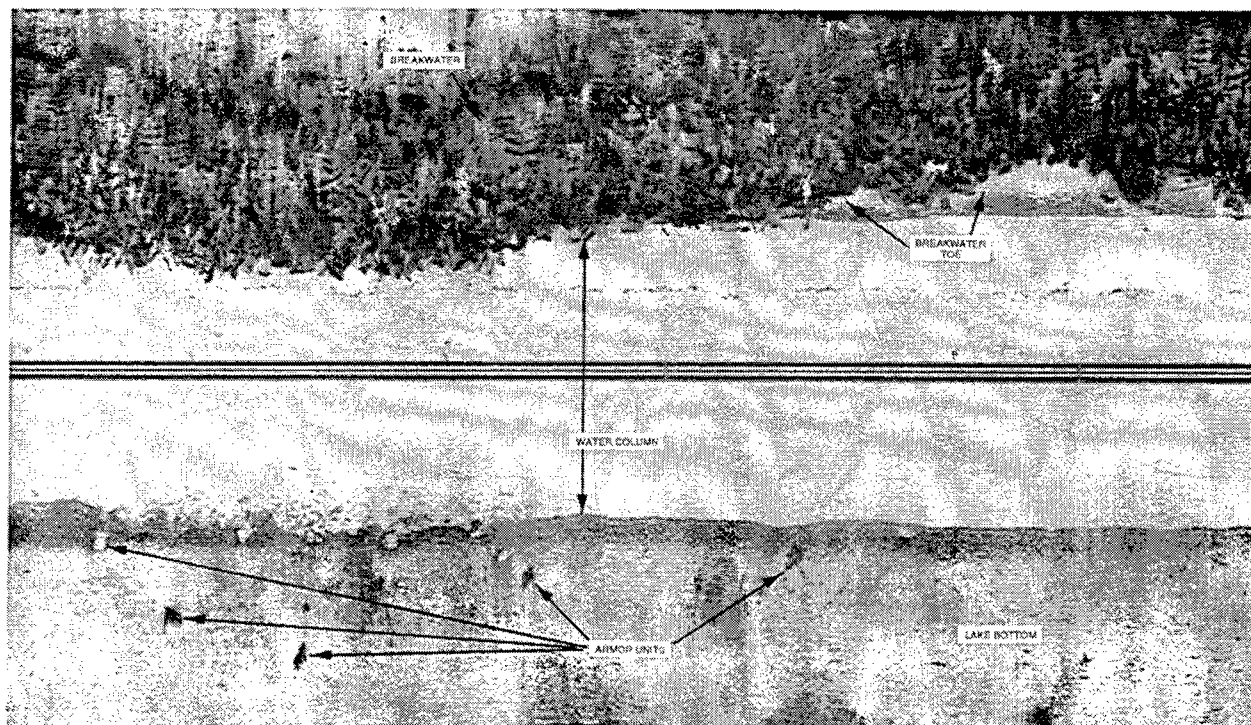
Figure 19. Lakeside SSS record showing individual armor units

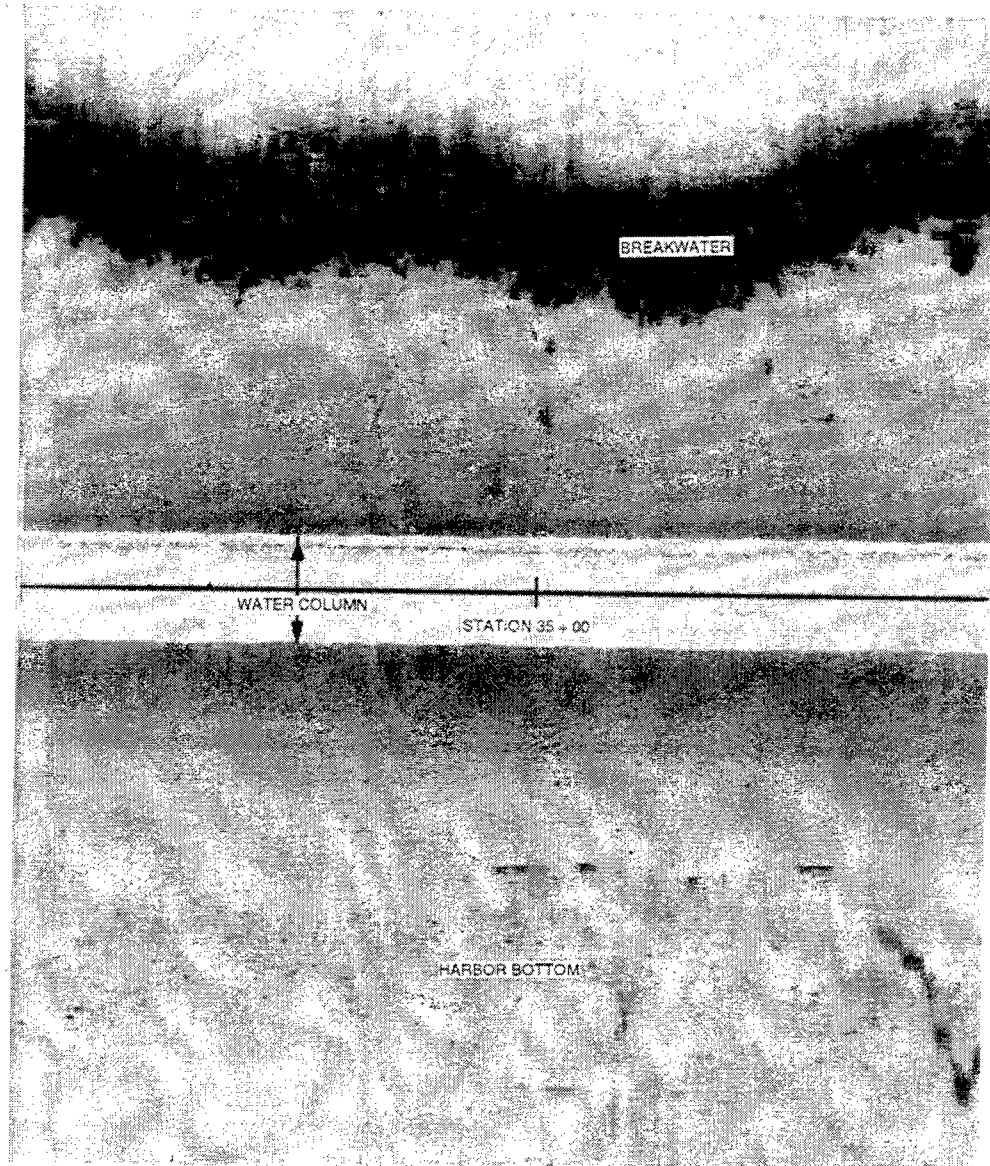
Figure 20. Typical portion of harborside area (SSS record, Station 30+00 to 40+00)
